2.0 SITE ASSESSMENT

Between October 2017 and June 2018, CEC conducted site assessments and monitoring of the project areas. Geographic locations of the various features were collected using global positioning systems, and these along with photographs and field notes were assembled in a project site assessment web-based geographic information systems (GIS) application (see Figure 2). Descriptions of the main site features follow.

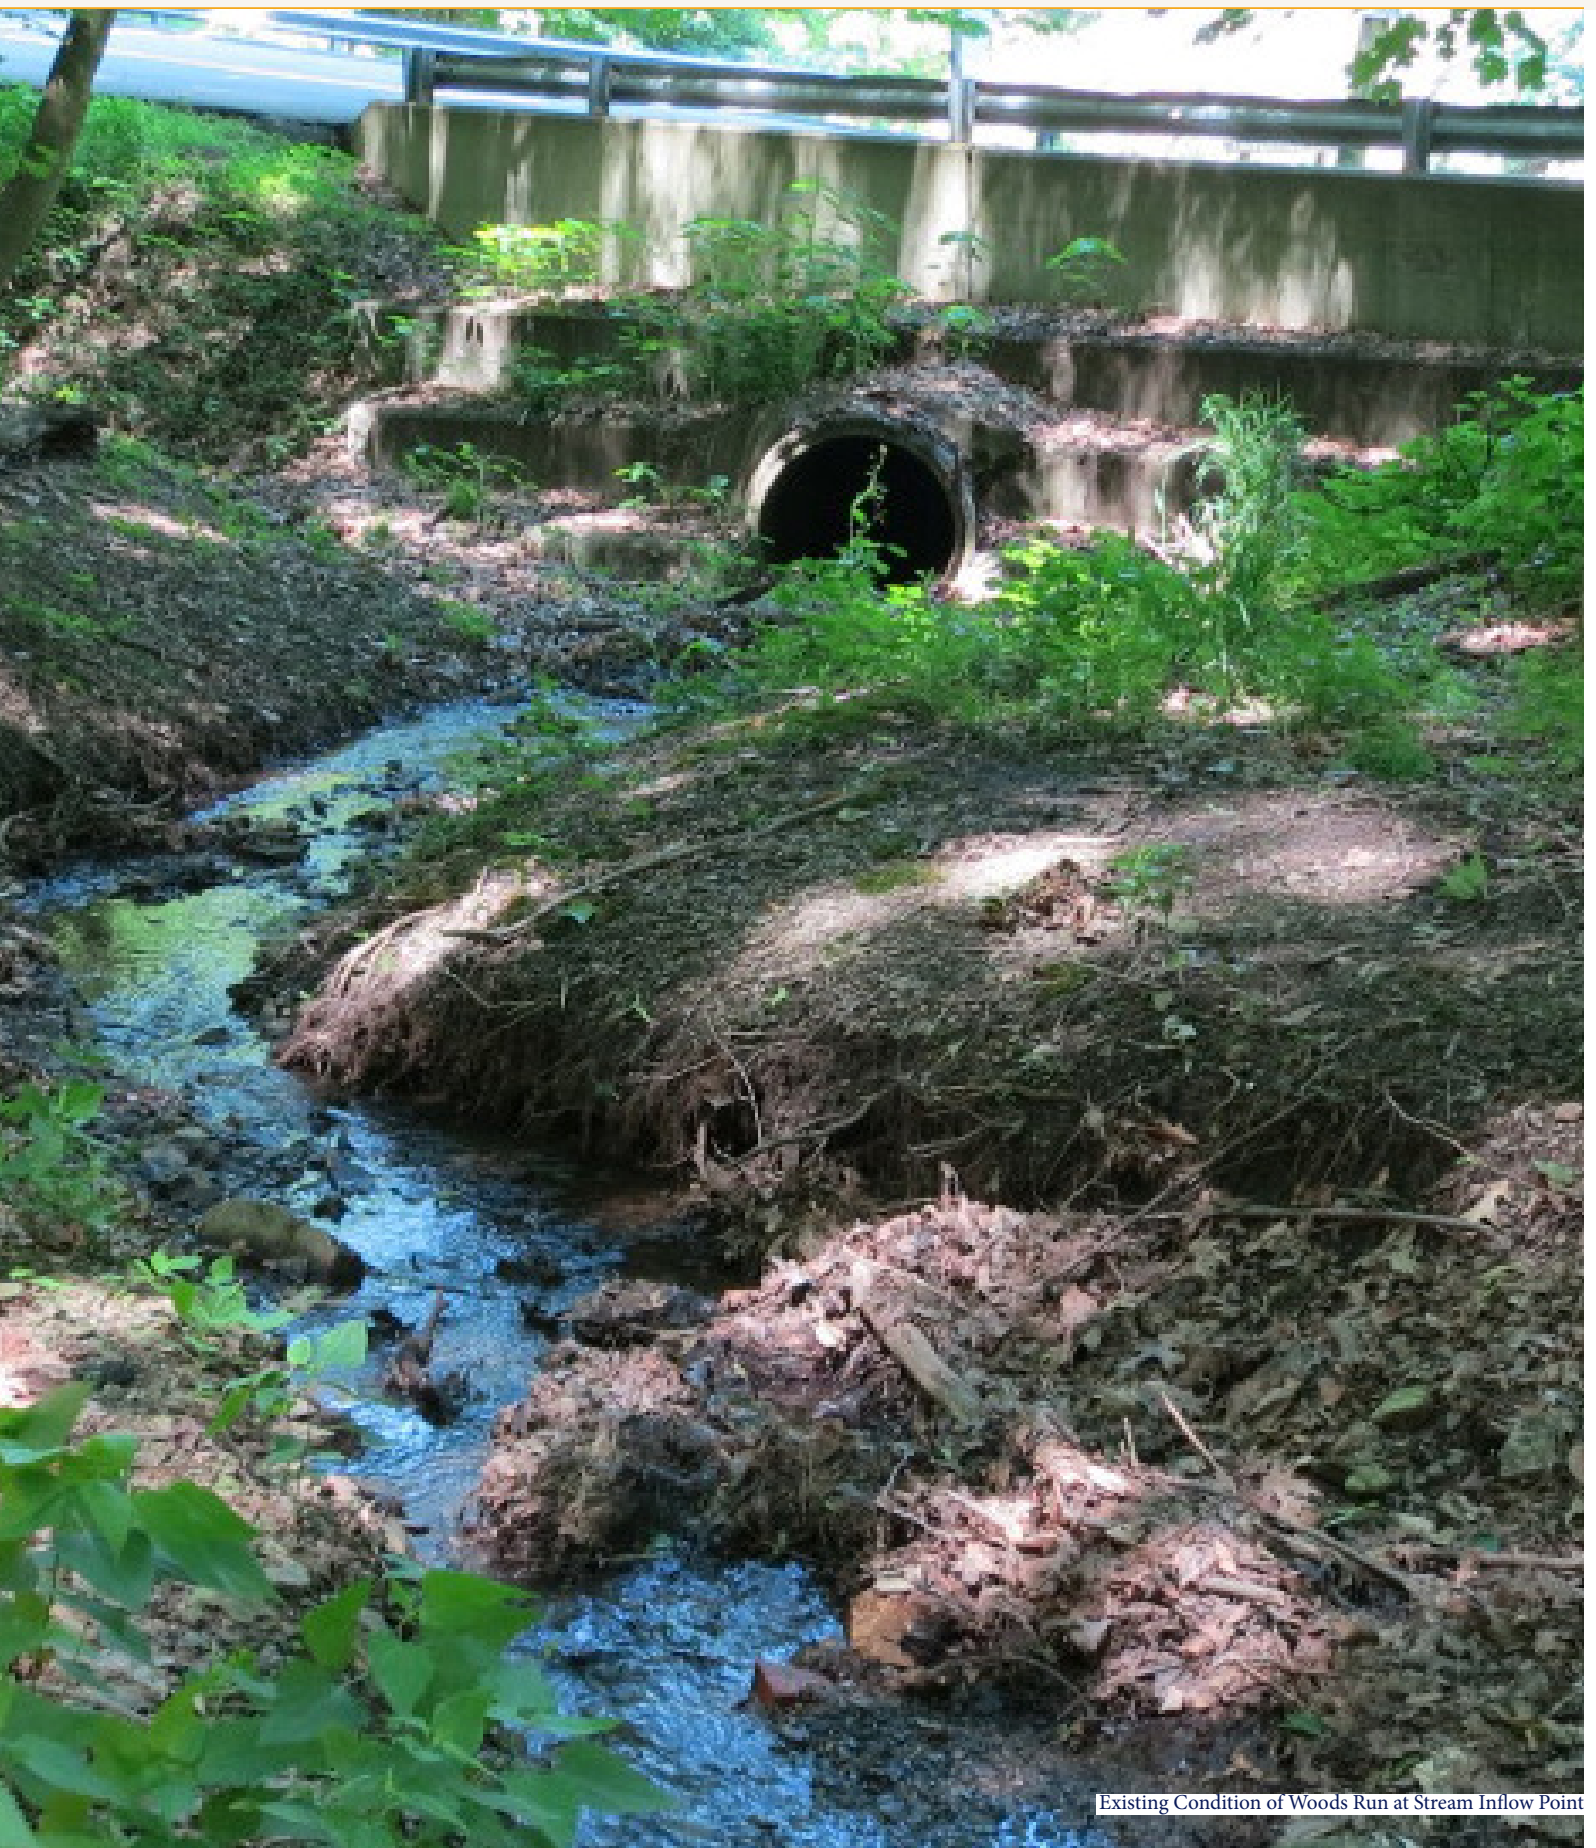
Existing Condition of Woods Run at Stream Inflow Point

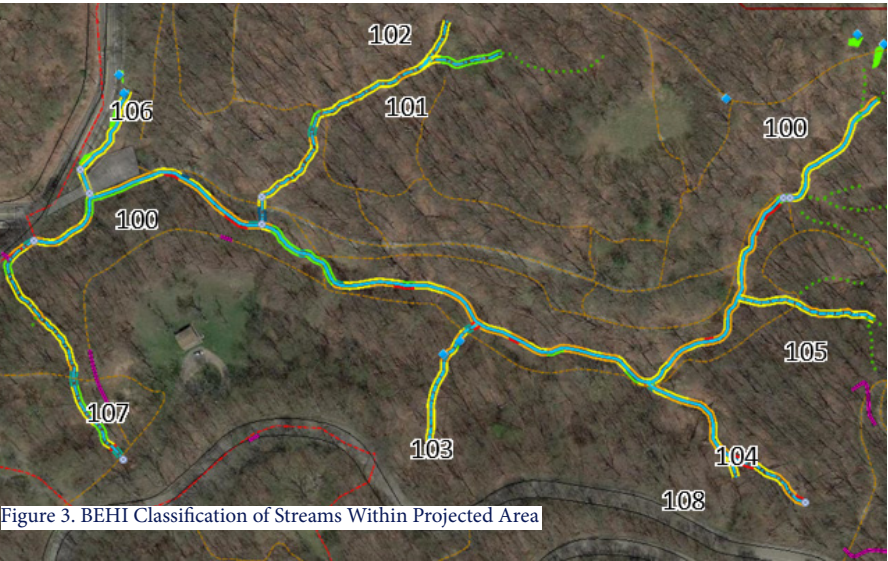
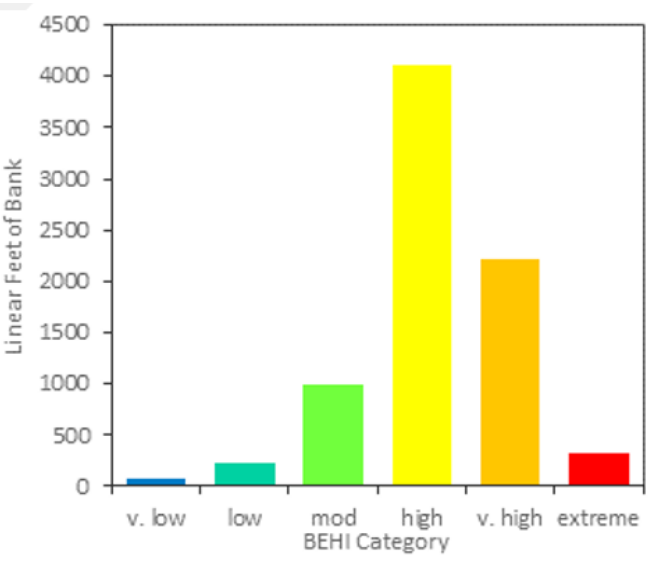
Figure 3. BEHI Classification of Streams Within Projected Area

Table 1 presents summary characteristics for each stream in the project areas. Figure 3 displays BEHI classifications for each stream. Figure 3. Bank Erosion Hazard Index (BEHI) classifications of streams (numbered) within the project area (left) with total linear feet in each category (colors correspond to map). Wetlands are green polygons in the map. Seeps are blue diamonds. High erosion areas along trails are purple.

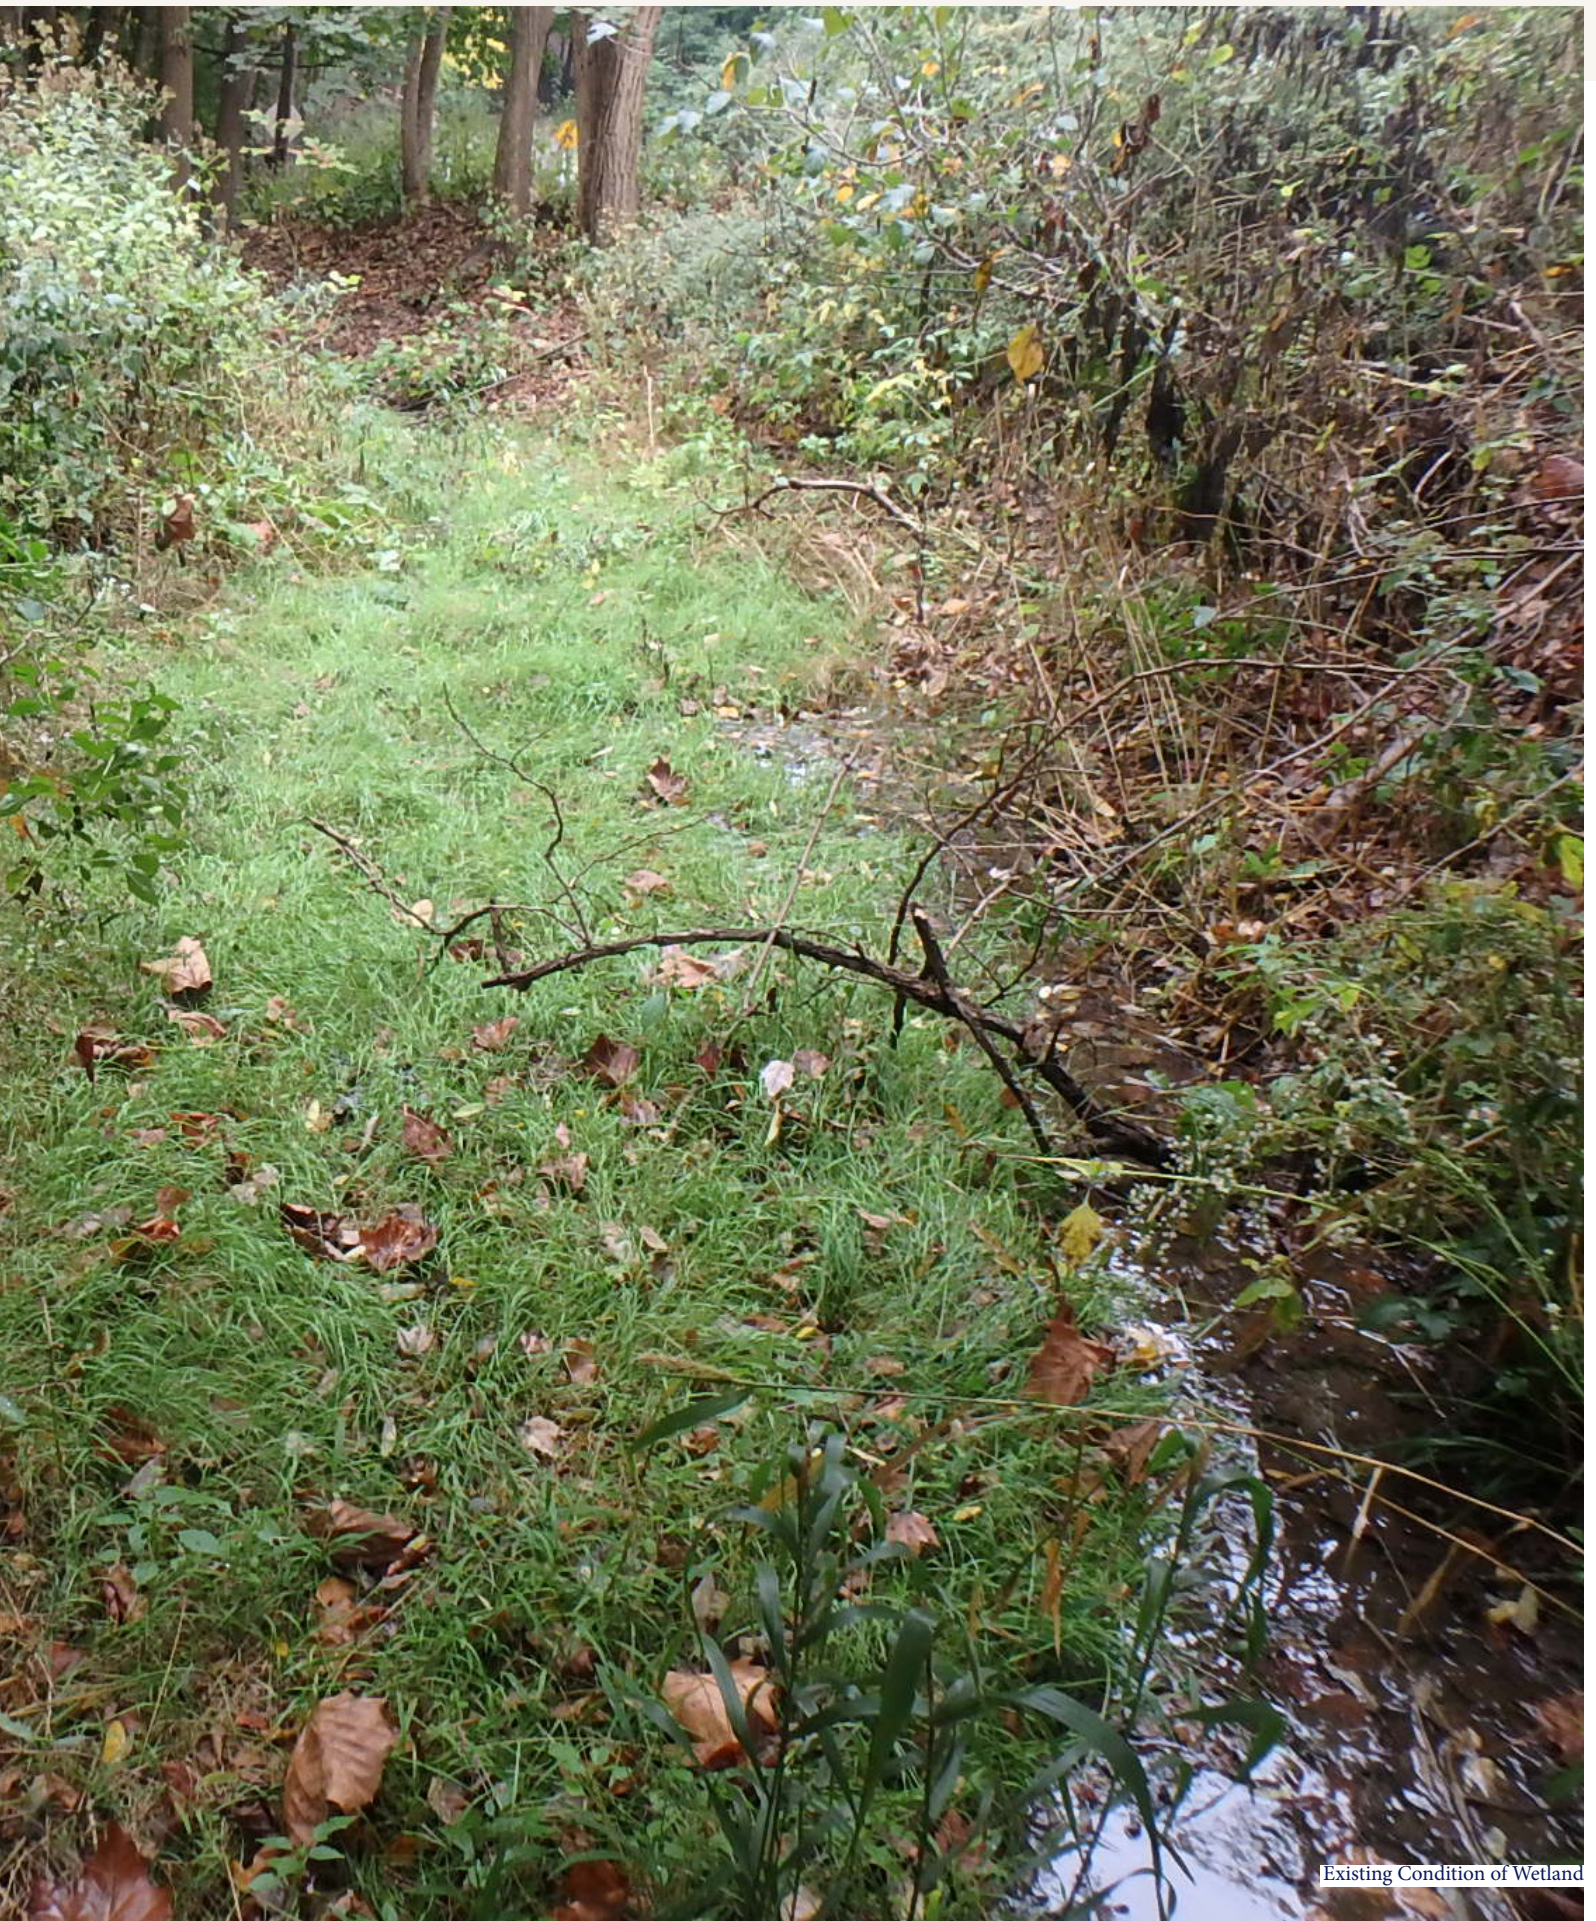
Three wetlands were located within the project area (Table 2). All three wetlands were hydrologically sourced by seeps. KKF-001 and KKF-003 are sourced by hillslope seeps. Wetland KKF-002 is also sourced by a seep that emerges on the right descending bank of a road-side swale. A fourth seep was identified at the junction of Myrtle trail and Archery trail. Two seeps were located along stream 103 and a broad seep flows onto Wissahickon Trail to the east of stream 103.

Existing Condition of Wetland

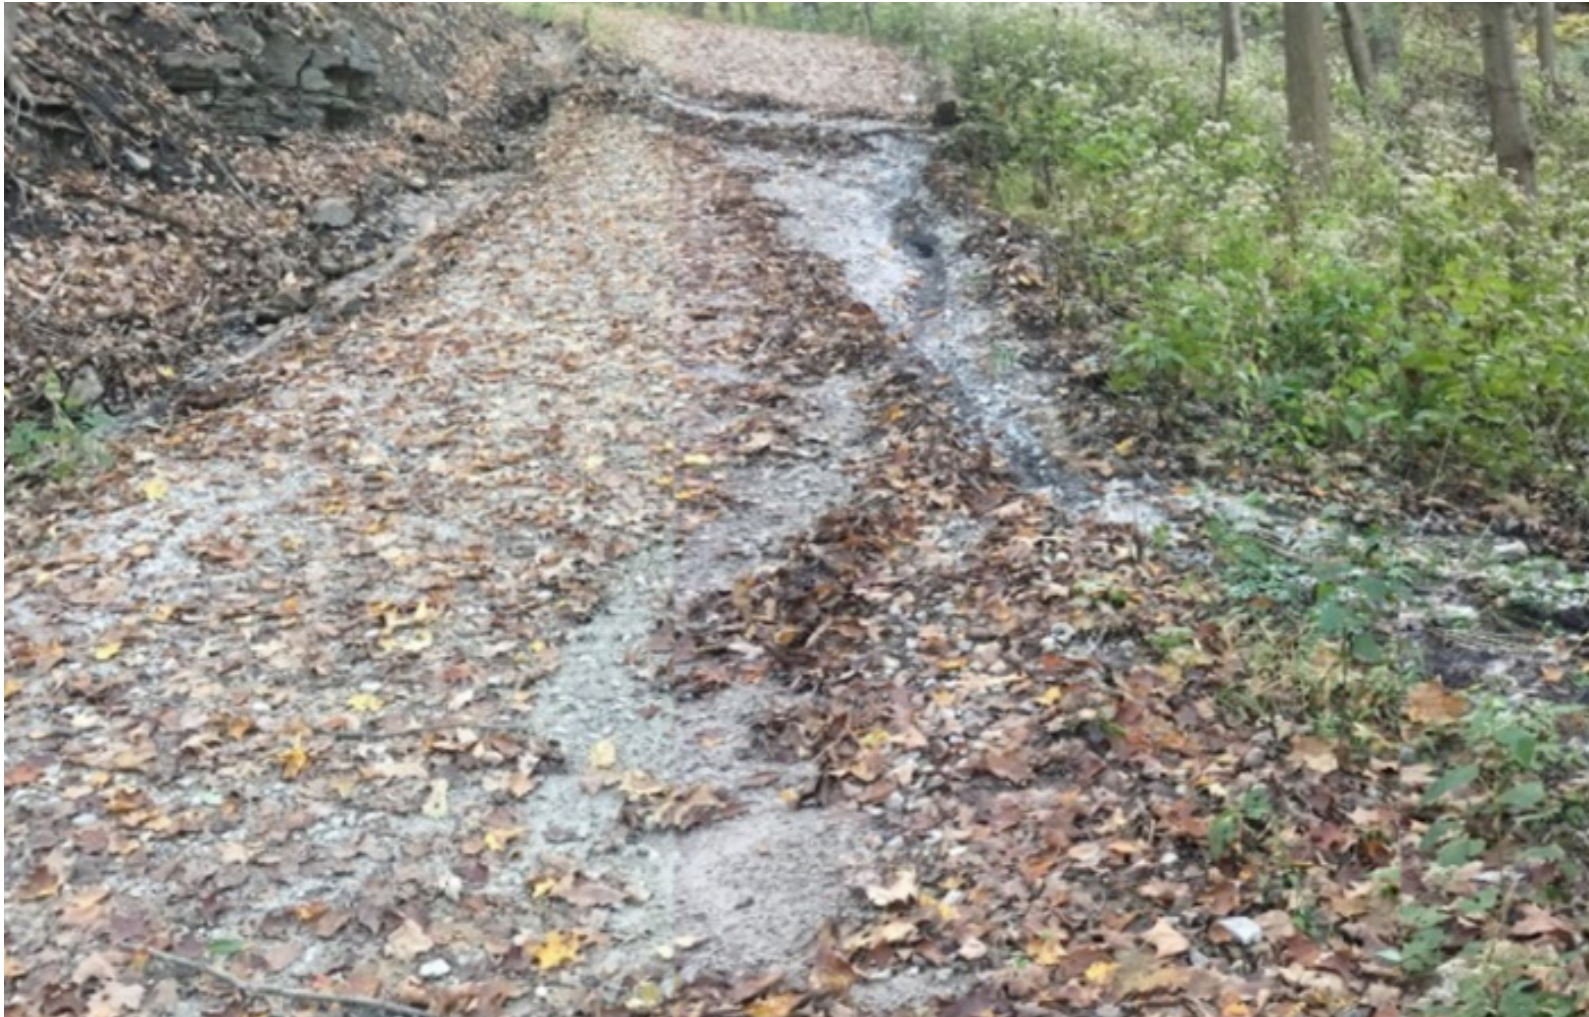
Trails were mapped and documented within the project area. Seven previously unmapped trails were identified. These unmapped trails were mostly manmade trails that connected two existing trails. Most of the trails show signs of erosion. The erosion is caused by a lack of understory vegetative cover in combination with excessive water flow from above neighborhoods and poorly maintained drainage infrastructure to shed water away from trails and prevent it from concentrating along creating scouring forces.

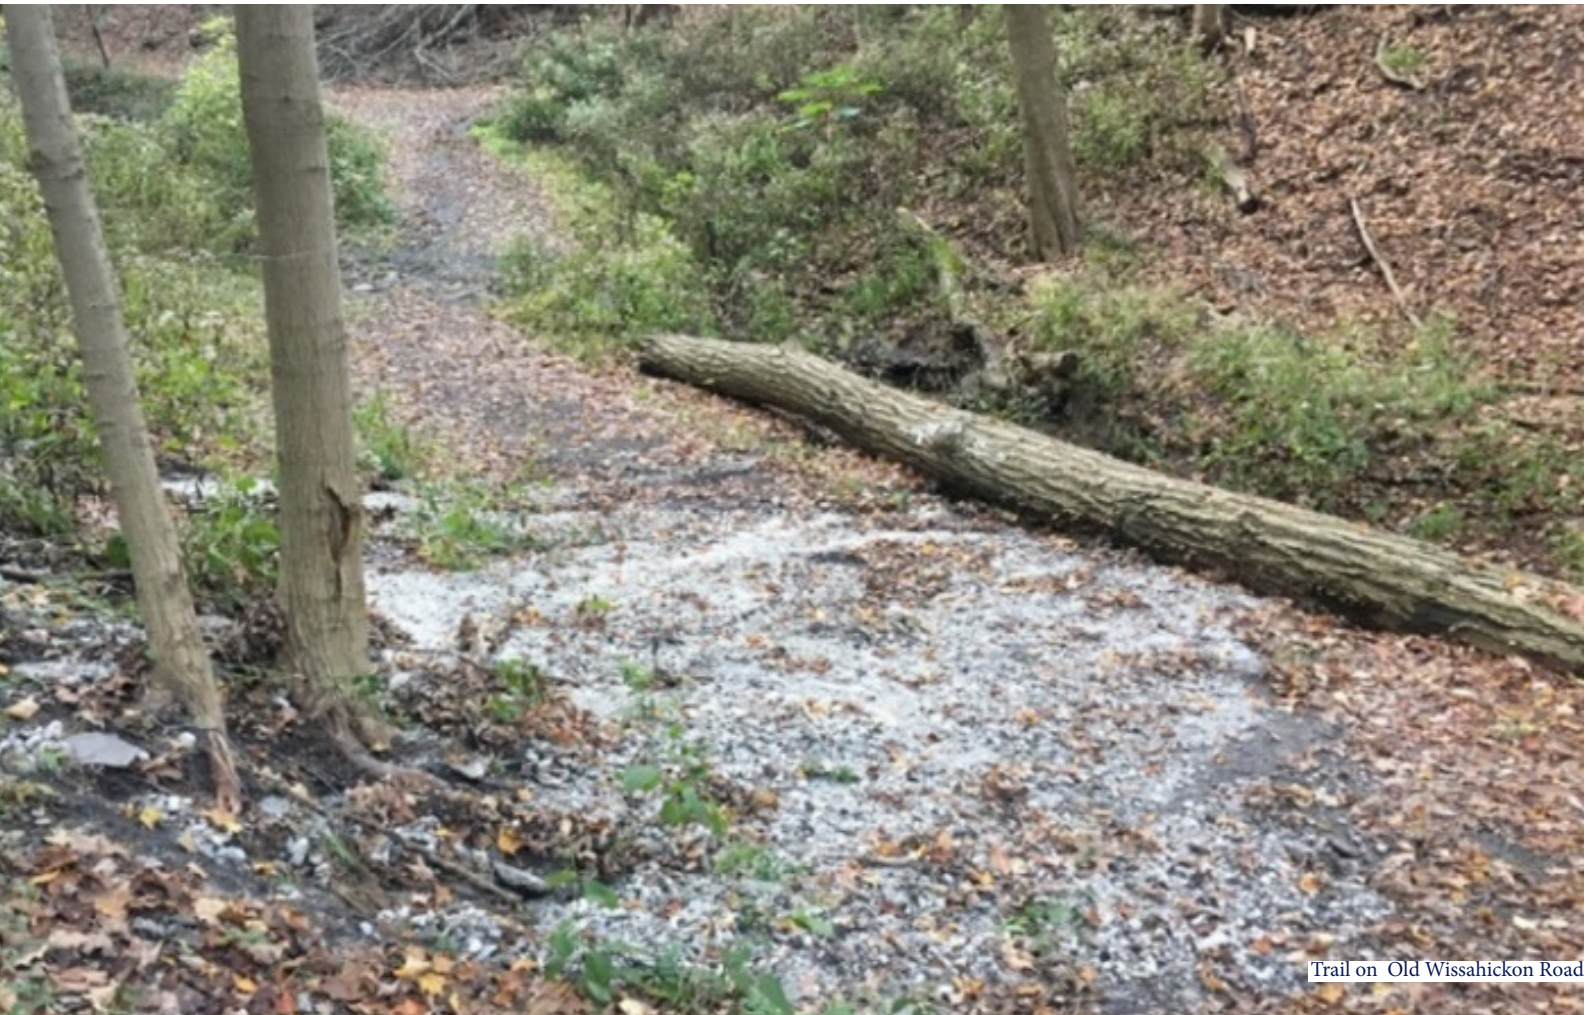
A different trail runoff issue occurs along Old Wissahickon Road. There is a Belgian block-lined ditch on the north side of the old road. This serves to concentrate flow from uphill, which creates torrents of sediment and debris- laden water during storm events to clog downstream infrastructure, causing storm pulses to jump the ditch and scour across the old road, contributing to sedimentation into the streams. Scoured areas appear to be repaired with reclaimed concrete, which does not resist erosion well. Furthermore, this

approximately 20-foot-wide trail appears to be overly wide given its current use. There appears to be no purpose for maintaining a gravel road inside the park at this location other than to provide access to repair the road itself. A different trail runoff issue occurs along Old Wissahickon Road. There is a Belgian block-lined ditch on the north side of the old road. This serves to concentrate flow from uphill, which creates torrents of sediment and debris- laden water during storm events to clog downstream infrastructure, causing storm pulses to jump the ditch and scour across the old road, contributing to sedimentation into the streams. Scoured areas appear to be repaired with reclaimed concrete, which does not resist erosion well. Furthermore, this approximately 20-foot-wide trail appears to be overly wide given its current use. There appears to be no purpose for maintaining a gravel road inside the park at this location other than to provide access to repair the road itself.

Trail on Old Wissahickon Road
